Manhole Inspection Summary

Manhole # S27CC_005MH

Location Address: **633 MOSHER ST**

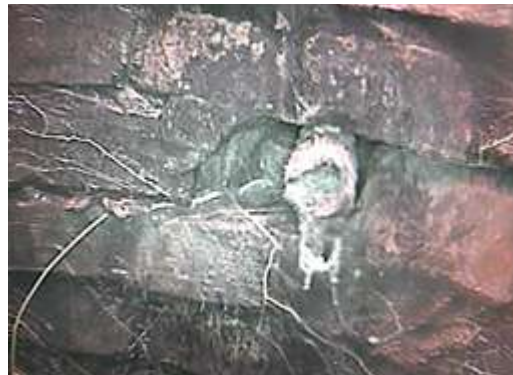
Defect 2

UNKNOWN POSSIBLE ILLICIT
CONNECTION

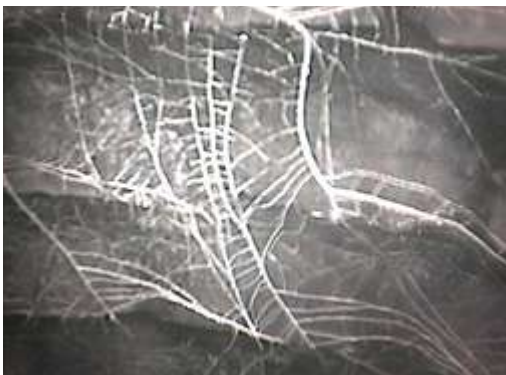
Defect 1

Condition: ☐ Sound ☐ Cracked ☒ **Root Intrusion** ☐ Loose Brick ☐ Deteriorated

ROOT INFILTRATION ON BARREL
WALL

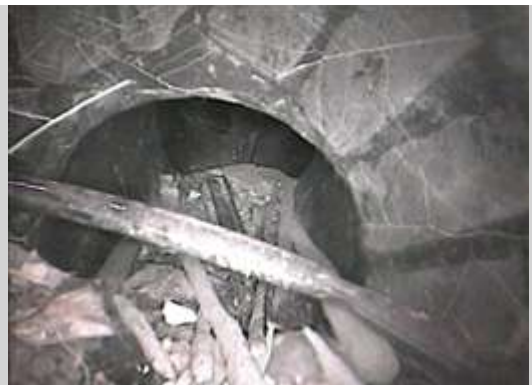
12 O'Clock Outflow

8 in. Circular Gravity Sewer
Pipe Out @ 12 O'Clock

Deposits: ☐ None ☐ Mud ☐ Sludge ☒ **Debris** ☐ Grease

Silt Depth: **2** (in.) Deposits Extent: **Light**

Infiltration: **None** Pipe Seal Cond: **Roots**
